Bridge 57, Huyton

The electrification of the main Liverpool to Manchester Victoria rail line required the strengthening of a large pedestrian underpass, Bridge 57 in Huyton, Liverpool.

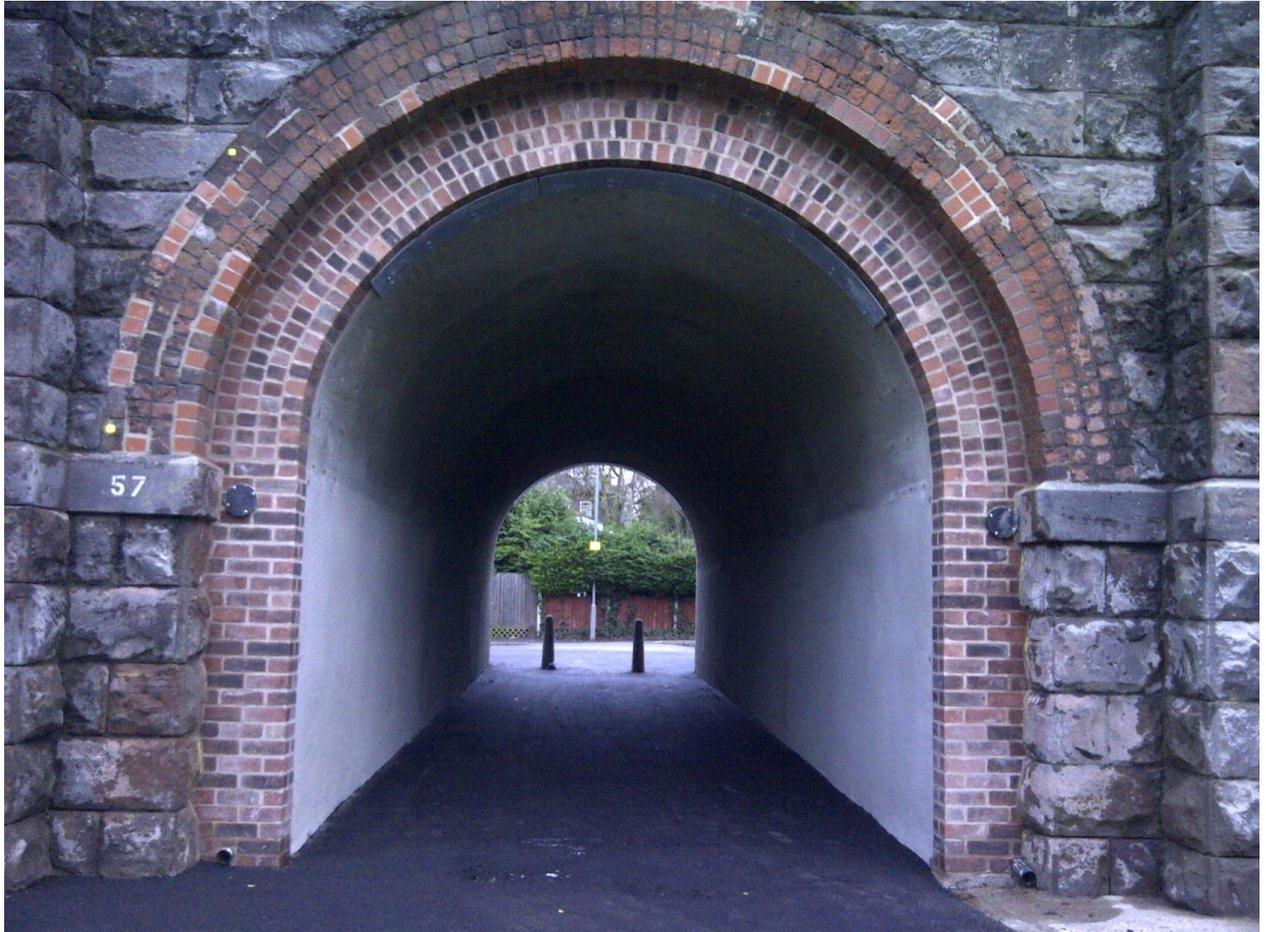
Bridge 57 completed.
